DEPARTMENT OF NATURAL RESOURCES
DIVISION OF OIL, GAS AND MINING

TO: Minerals File
FROM: Paul Baker, Senior Reclamation Biologist
RE: Site Inspection, Georgia Pacific, Eagle Canyon Quarry, M/015/050, Emery County, Utah

Date of Inspection: February 11, 2003
Time of Inspection: about 12:30 to 1:30 p.m.
Conditions: Mostly cloudy, 20's
Participants: Russ Harms, Georgia Pacific; Dean Nyffeler, BLM; Susan White and Paul Baker, DOGM

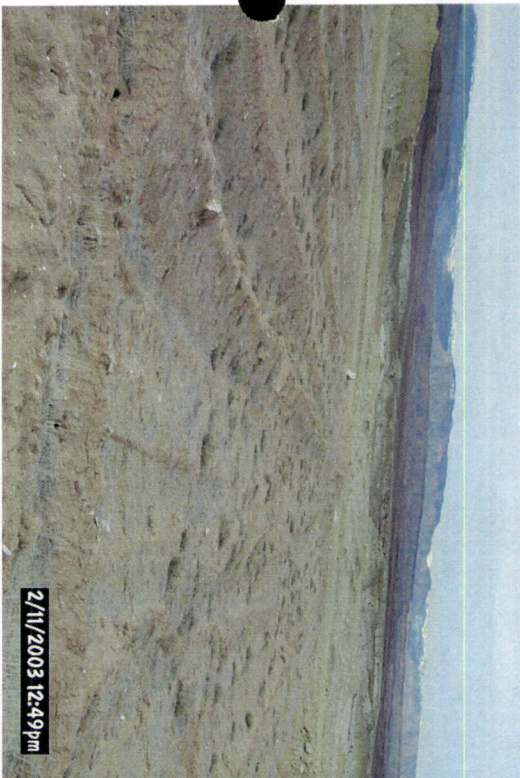
There are several areas near the road that have been regraded (though the operator may not have intended that this regrading be final), and there are windrows or berms in some of these areas that are not, for the most part, on the contour (Photo 1). Photo 2 shows a soil stockpile near the road.

Photo 1. Graded area. Although this photo is tilted, note that the berms are not on the contour. There is not a lot of vegetation, but the cover is likely at least 70 percent of undisturbed surrounding areas.

The areas that have been graded and have good vegetation cover should not be redisturbed if possible. The berms in these areas will probably persist for an extended period, but since it is so difficult to establish vegetation in this area, it would be better to leave the berms than risk not being able to get anything to grow. Those areas that have berms but do not have adequate vegetation will need to be regraded to eliminate the berms. These areas should be left as rough as possible to help retain water and increase the chances for revegetation success. If any sort of berms are left, they should be parallel to the contour.

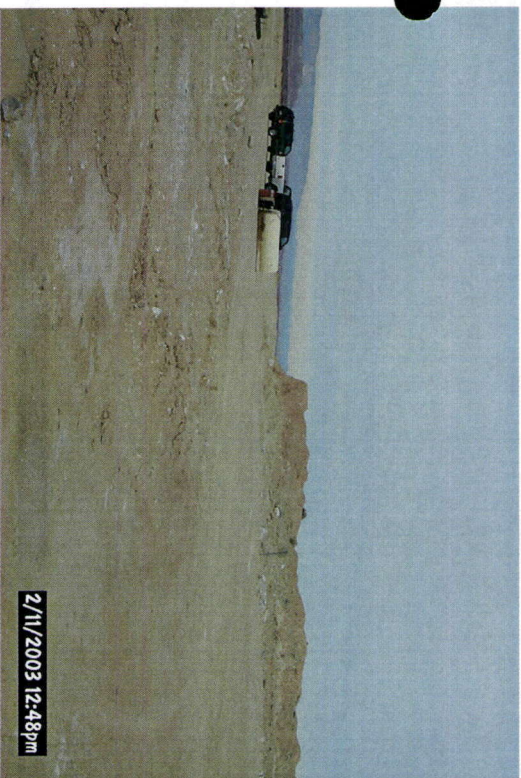
Just to the right of the area shown in Photo 2 is a drainage that has been blocked by the road. We expected to see a culvert under the road, but there was none. There was evidence that water had flowed in this channel and been blocked by the fill placed for the road.

Photo 2. The pile on the right side of center is a soil stockpile.

The operator should put signs on the soil piles so this material is not accidentally used as fill when the site is graded.

The watershed that drains to the blocked drainage is not large, so I do not feel it is necessary to install a culvert under the road. It will be necessary for the operator to restore this drainage during reclamation.

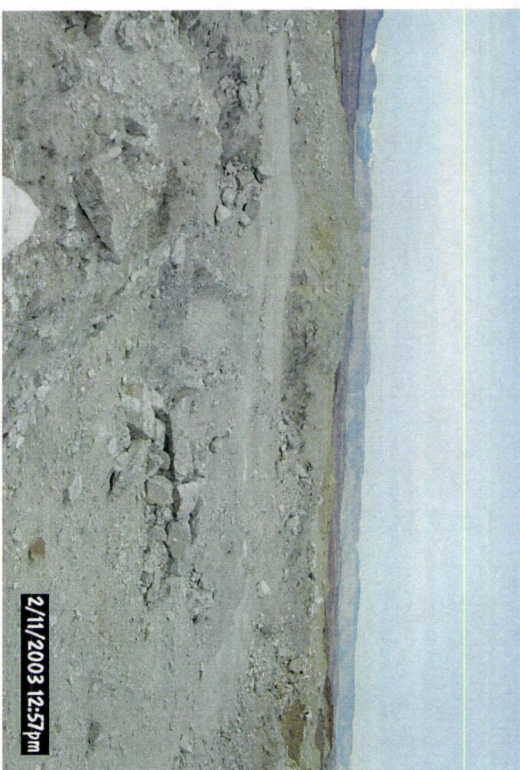
The western parts of the disturbed area farther from the road have not been graded. This area basically consists of about five quarries in close proximity to each other. Some of the area is shown in Photos 3-6.

Photo 3. Some of the disturbed area that has not been regraded.

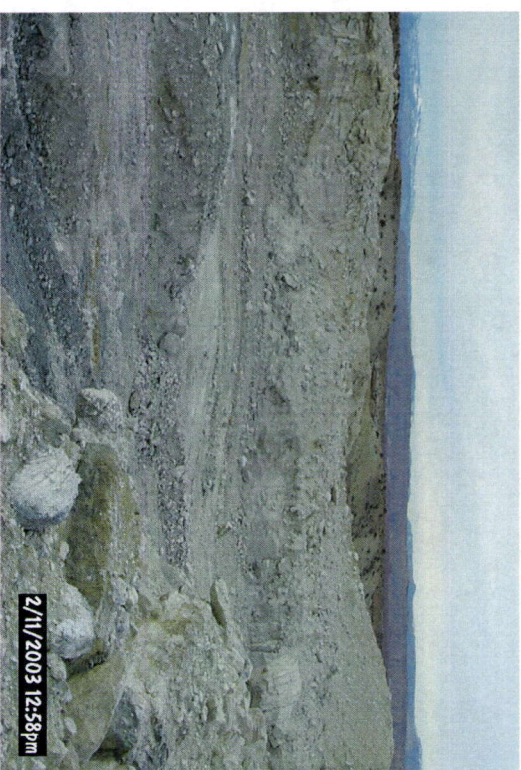
Photo 4. One of the quarries on the west side of the disturbed area.

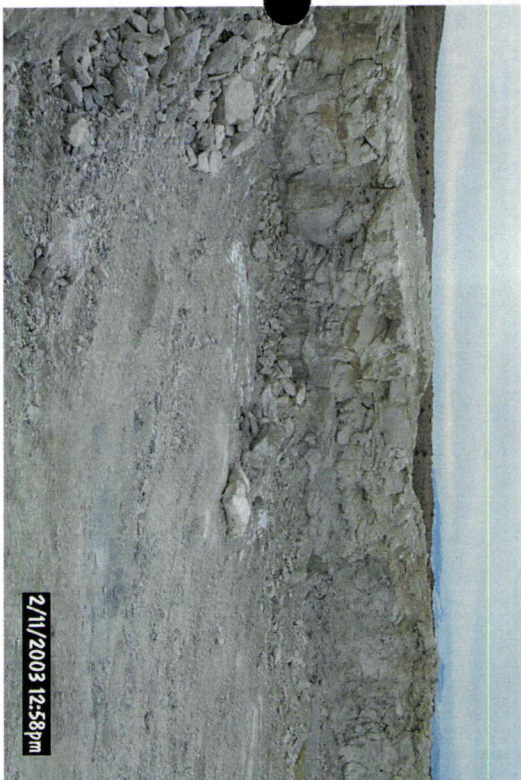
Photo 5. Another quarry on the west side of the disturbed area.

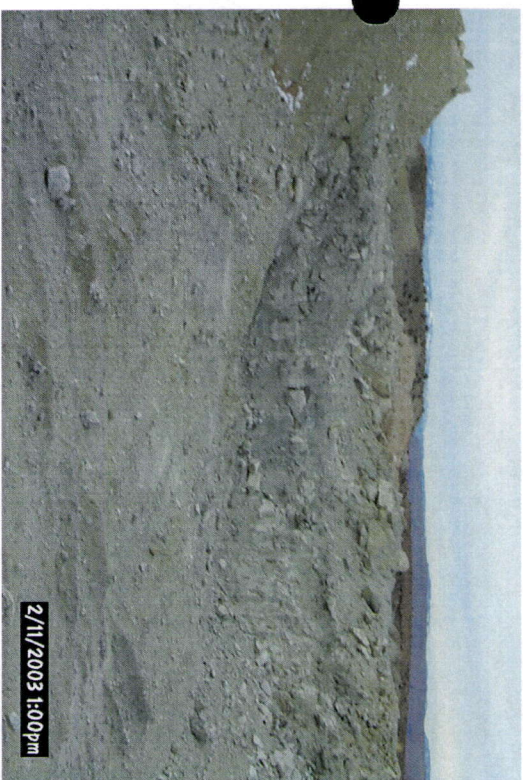
Photo 6. Another quarry on the west side of the disturbed area.
